LAKE WICHITA

HOLLIDAY CREEK, WICHITA FALLS, TEXAS LOCAL FLOOD PROTECTION

SPILLWAY FOUNDATION REPORT

U.S. ARMY ENGINEER DISTRICT, TULSA CORPS OF ENGINEERS TULSA, OKLAHOMA

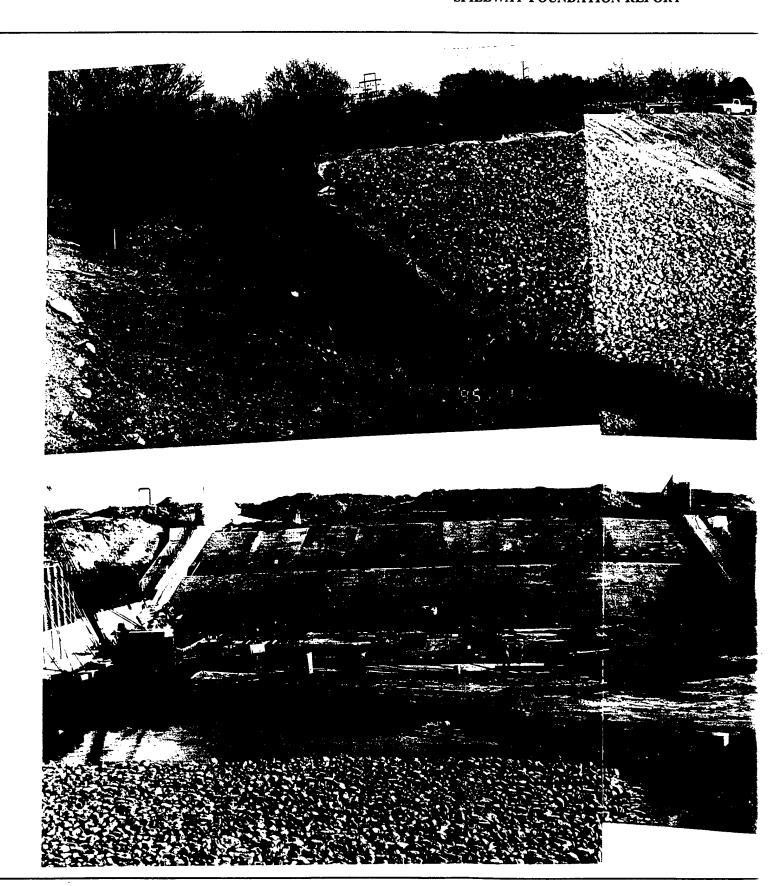
Photo 1. Composite view of the downstream portion of the main spillwa 25 JANUARY 1995

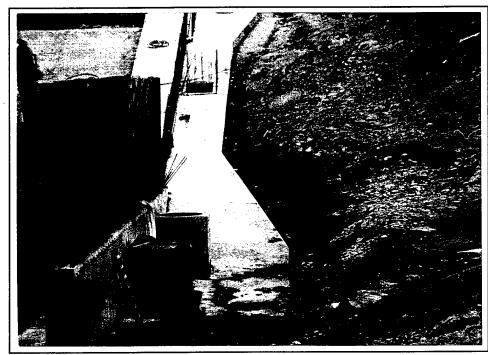
Slickensiding (not due to equipment) was observed in the shale. The clay shale also exhibited jointing with no discernible bed displacement, possibly being ancient desiccation cracks. There appears to be a displacement in the base of the sandstone on the right side of the spillway excavation at station 413+30 and also on the left side of the excavation at station 415+56. There were wet spots near each of these displacements. The upstream wet spot is located on the left side of the spillway (northwest), approximate station 415+46, 130 feet left of the spillway centerline. The spot is about 5 feet above the floor excavation and is moist around several cracks and appeared to flow where they coalesced (see photos 3 through 5). This was a minor problem during construction as the weather was dry. The upstream wet spot is about 200-250 feet from the lake and below the lake level. The downstream wet spot was located on the right side of the spillway, approximate station 413+30, 100 feet right of centerline, and had a pump in it most of the time. This wet spot seems to be where the sandstone butts up against a dark shale. The sandstone may be a stream channel deposit and the wet spot may be from a pond just uphill and off the property, (see photos 6 through 8).

Photo 3. Wet spot on the left side of the spillway at base of the sandstone.

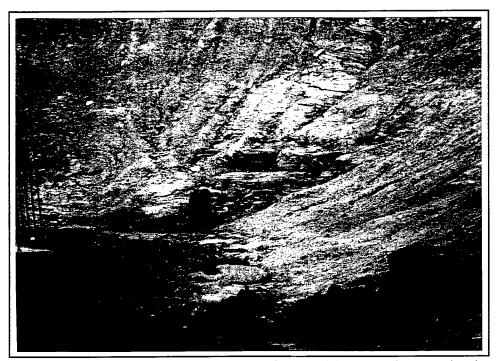
Photo 5. Wet spot on the left side of the spillway at fracture in the sandstone.

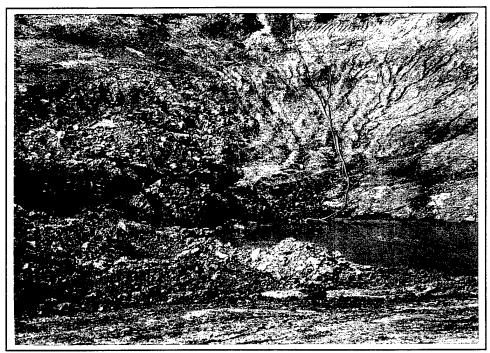
Photo 6. Wet spot on the right side of the spillway below the stockpond. Note wet area within the loose material on the left side of photo.

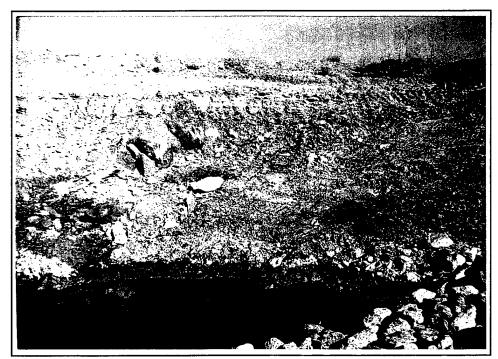
Photo 7. Area above wet spot on the right side of the spillway after some detritus removed. Note wet sections in sandstone on left and center of photo.

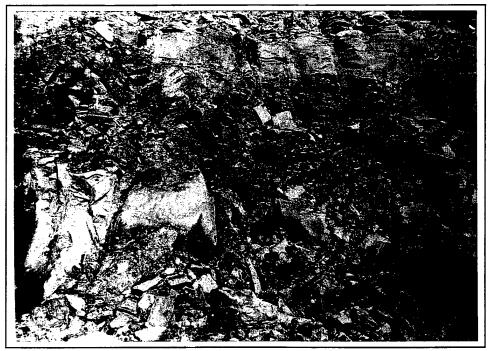
Photo 8. Close-up of area near the center of photo 7.

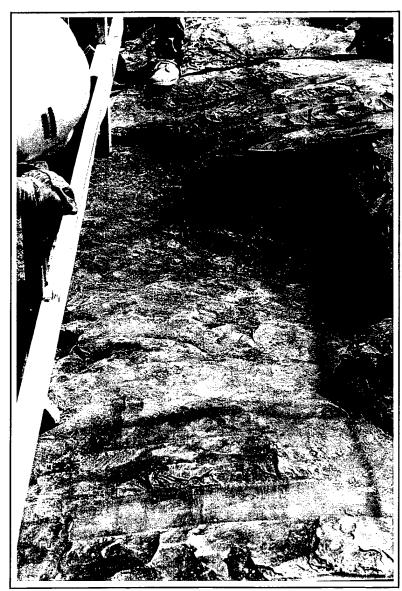
Photo 9. Station 415+88 to 415+90, 40 to 50 feet right of centerline showing the blocky, non-fissionable structure of the claystone.

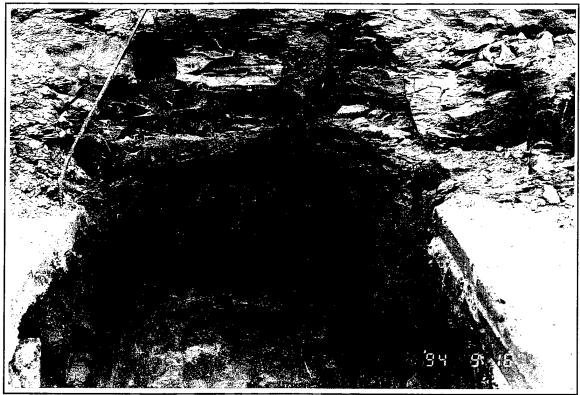
Photo 11. Record photo of foundation at Station 416+50 to 416+54, 117 feet left of centerline to the end of the trench. Note variegated claystone.

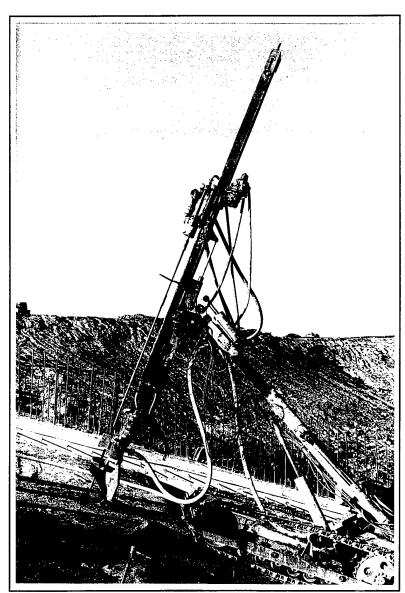
- 5-02. <u>Foundation Anchors</u>. There are 84 #9 rebar foundation anchors in the spillway. There are 36 anchors, grouped 12 across in 3 rows, located in the stilling basin, one row of 12 anchors about midway in the incline chute, and 3 rows of 12 anchors at the bottom portion of the incline. The anchors are 8 feet apart, center-to-center, transverse to the centerline, and 9 feet apart parallel to the centerline within the appropriate groupings. Six-inch-diameter holes were drilled 15 feet into the foundation at approximate right (90°) angles to the protective concrete covering. Only the 36 anchors in the stilling basin are vertical. The anchors were grouted using a nonshrink Portland cement grout. Two anchor pull-out tests were performed in accordance with the specifications and the results met all requirements. See photos 14 through 18.

Photo 14. Drilling anchor holes.

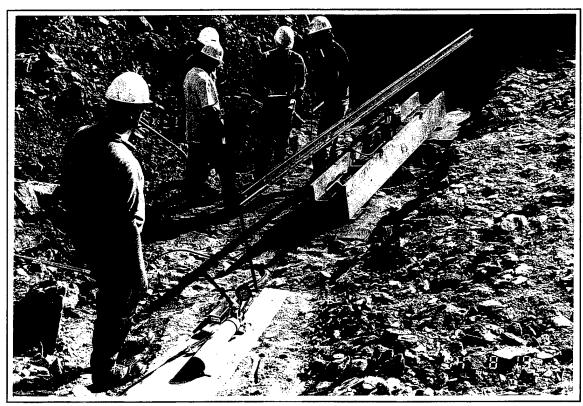
Photo 15. Setup for the anchor pullout test.

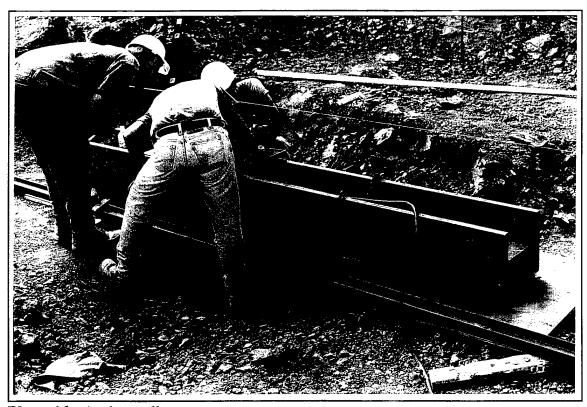
Photo 16. Anchor pullout test.

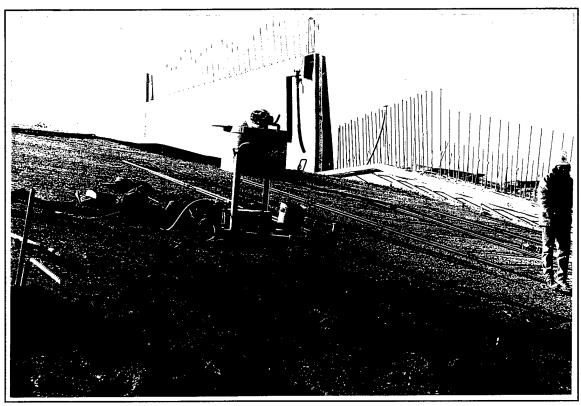
Photo 17. Setup for grouting the anchors.

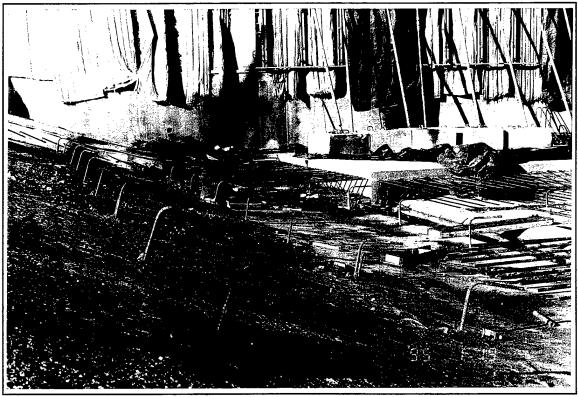
Photo 18. Inplace anchors.
